A CRASHWORTHY ARMORED PILOT SEAT
FOR HELICOPTERS

Bernard Mazelsky

Naval Air Development Center

4. TITLE (and Subtitle) A CRASH WORTHY ARMORED PILOT SEAT FOR HELICOPTERS		5. TYPE OF REPORT & PERIOD COVERED Final Report
7. AUTHOR(s) Bernard Mazelsky ARA, Inc., W. Covina, Calif. 91790		6. PERFORMING ORG. REPORT NUMBER USAAVSCOM TR 73-34 ✓

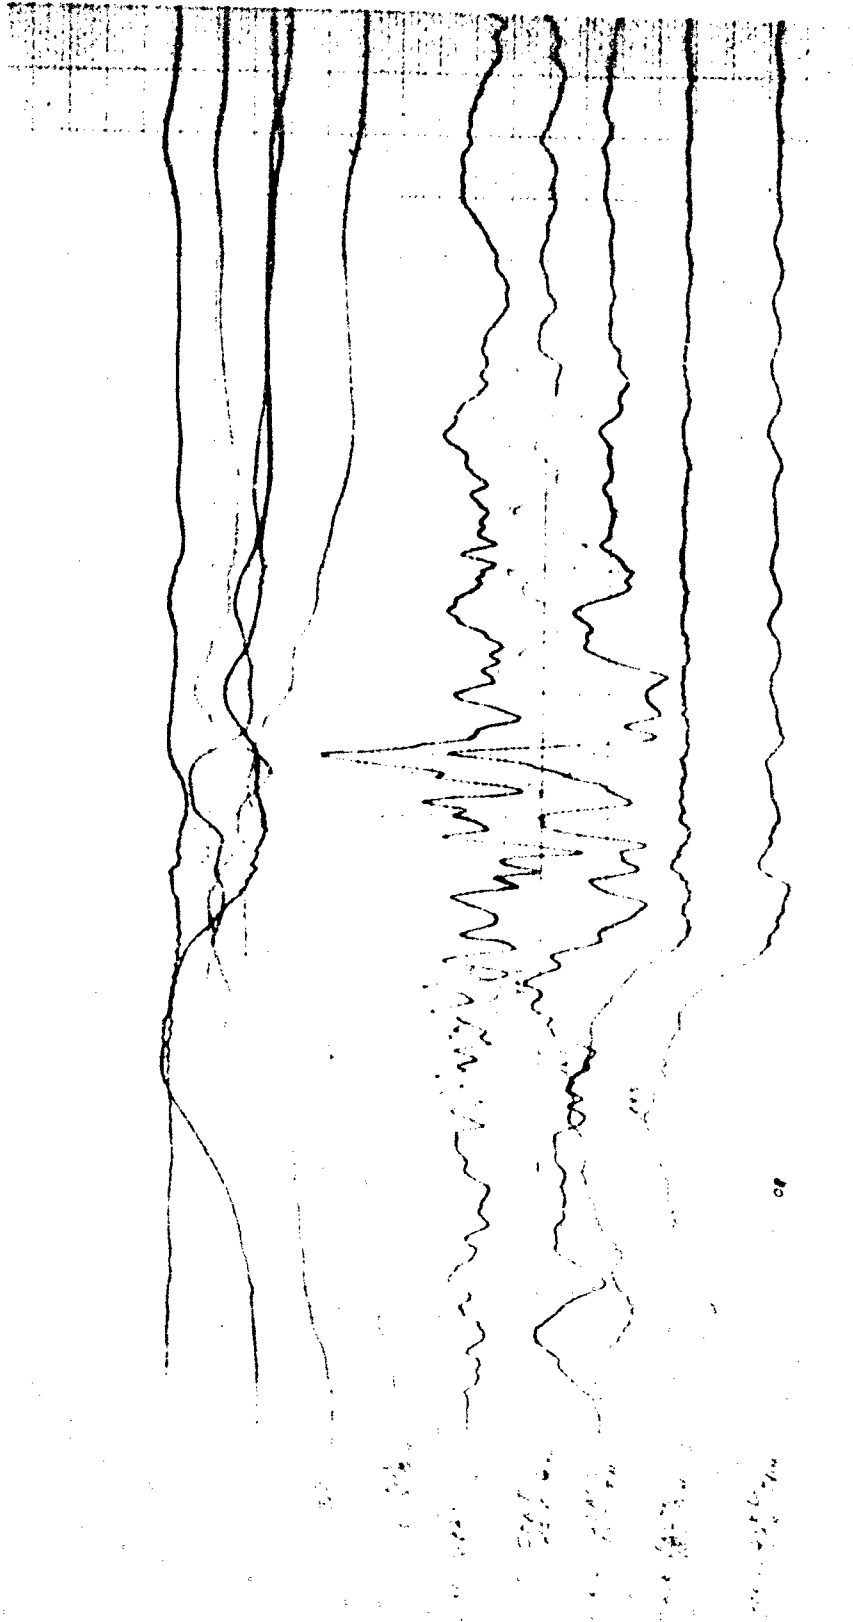
Figure 29. Forward Sled Test
-54-

"The seat was subjected to the Test #2 condition of Table IV of MIL-S-58095(AV). The bucket was tested in the full-up position. Because of the failure of the rail mount bolts experienced in Test 3B, the coarse-threaded 1/4 inch bolts were replaced by MS-20004 allen bolts. Inspection of the system after the test event showed the seat to be intact with the dummy restrained by the harness straps. The cantilevering action of the dummy on the forward edge of the bucket plus the inertia load of the side panel assembly were sufficient to pull out some bolts retaining the seat back to the right side and rear of the seat pan. Five bolts along the right inboard side of the seat and six bolts along the bottom of the seat back pulled out of their tapped holes. However, the seat back and side remained attached. It was concluded that the seat met the design specification and performed satisfactorily, Figure 29." This was the last test conducted by NADC on this seat program.
